# THE NATION'S GREENEST HOUSE

## THREE YEARS LATER

In 2009, the Chicago home that Michael Yannell moved into was heralded as the most energy smart in the country. But some of its features didn't turn out as planned. Here's what worked—and what didn't

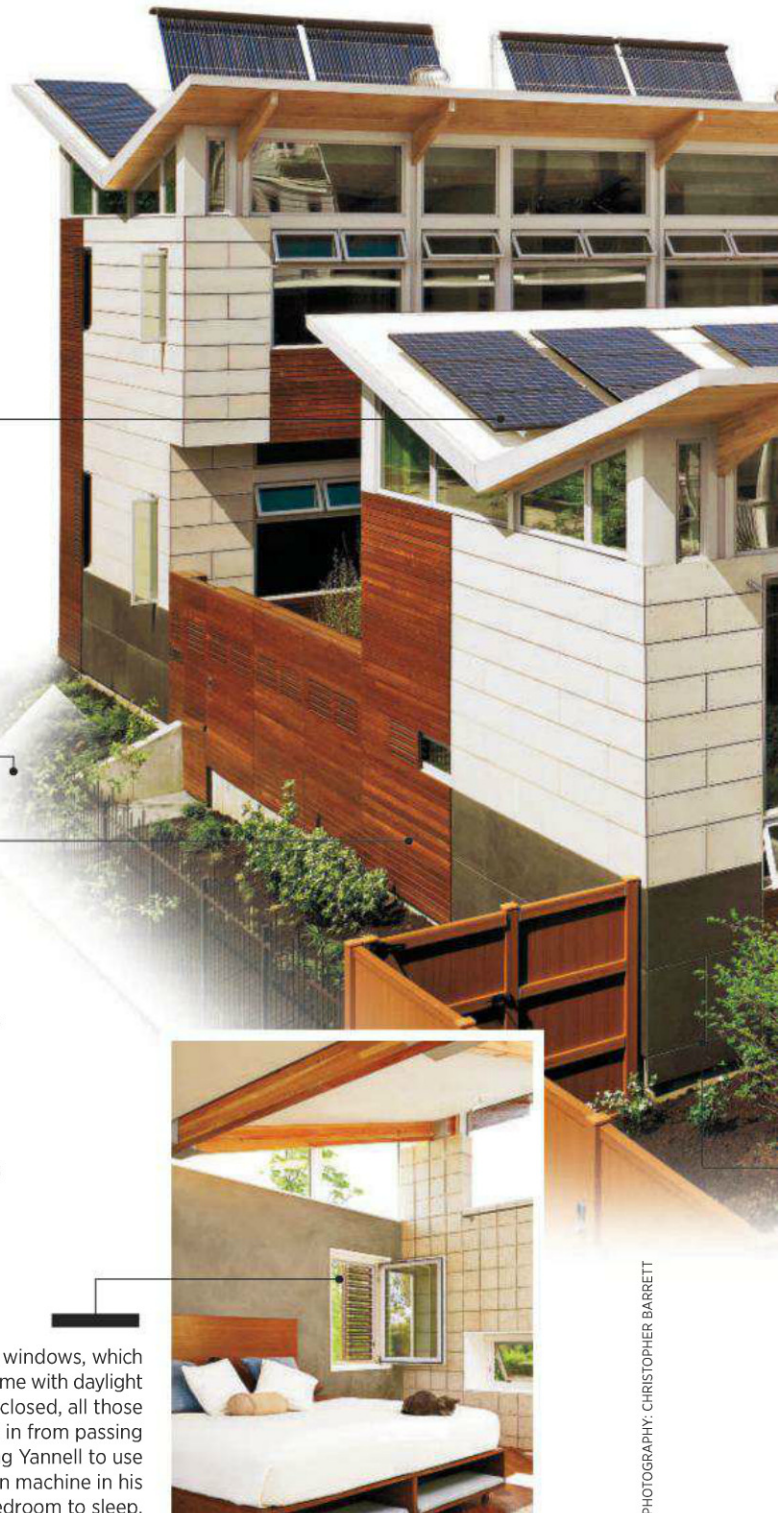
**The feature:** A V-shaped butterfly roof with 52 solar panels that power the house and hot-water system

**The result:** An incorrectly set equipment-room valve kept the solar system from working properly unless the air conditioning was running—resulting in the house operating at 80 percent efficiency in year one. After the valve was reset, efficiency hit the 95 percent mark in year two.

**The feature:** A wooden exterior coated with water-based sealer, which contains fewer harmful chemicals than traditional versions

**The result:** The sealer performed so poorly that the wood on the house's western wall has faded and looks weather-beaten.

**The feature:** Ninety-six windows, which help flood the home with daylight

**The result:** Even when closed, all those windows let noise drift in from passing Metra trains, forcing Yannell to use a noise-generation machine in his bedroom to sleep.

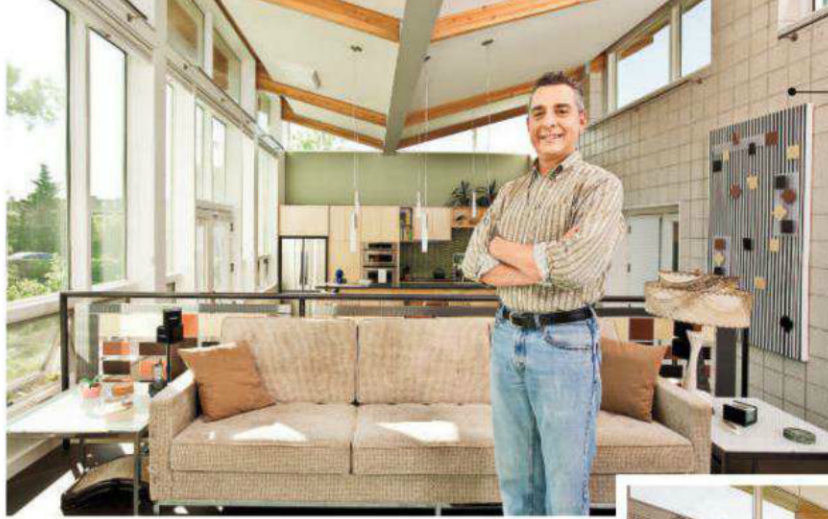
**The feature:** Seven different heating zones and five different cooling zones that minimize heating or cooling unused spaces

**The result:** A success—though Yannell (right) also keeps the house at no more than 63 degrees in winter and no less than 78 in summer to hit his goal: for the home to generate more energy than it consumes.

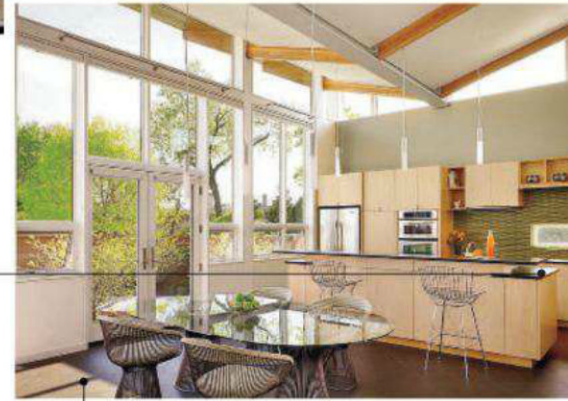
**The feature:** A kitchen countertop made of recycled newspaper that resembles manufactured stone  
**The result:** It scratches too easily. (A similar product proved more effective in the bathrooms, where it isn't exposed to chopping knives.)

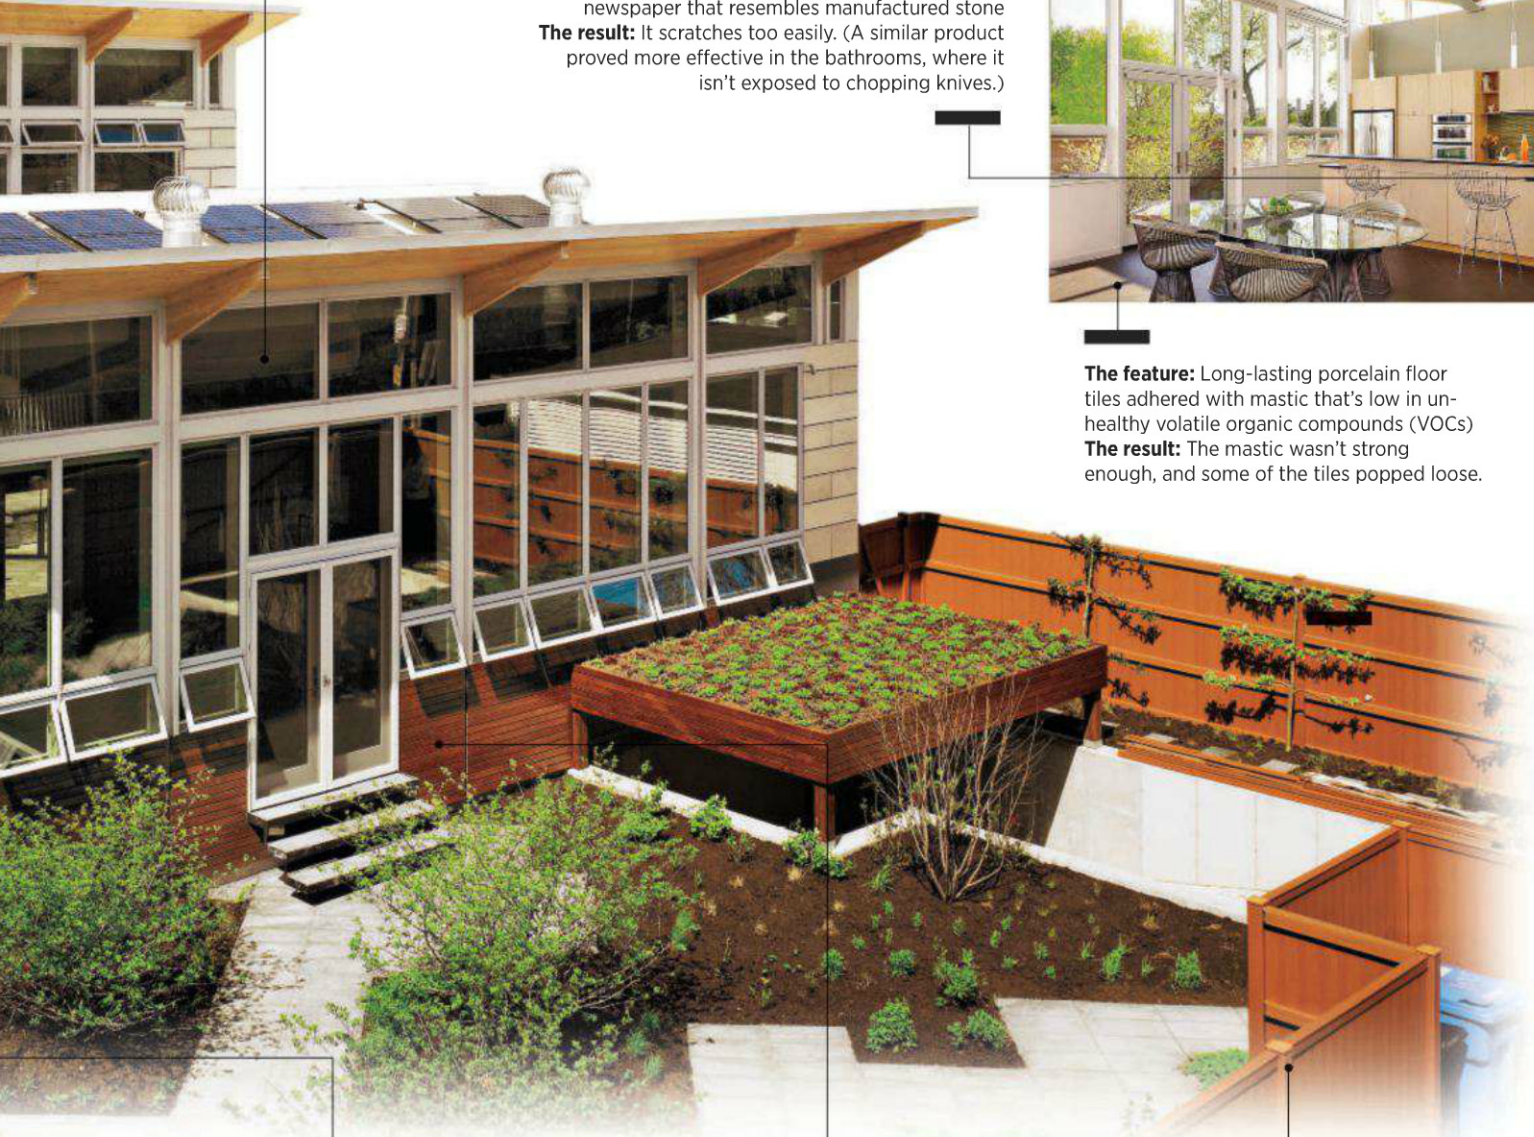
**The feature:** Long-lasting porcelain floor tiles adhered with mastic that's low in unhealthy volatile organic compounds (VOCs)  
**The result:** The mastic wasn't strong enough, and some of the tiles popped loose.
